SIKA AT WORK **REPAIR OF CONVEYOR BELTS IN GLOGOW COPPER MINE**

SIKA TECHNOLOGY: SikaBond® R&B 100

REPAIR OF DEPTH AND SHALLOW CUTS, THROUGH IMPLEMENTATION WITH RUBBER PATCHES

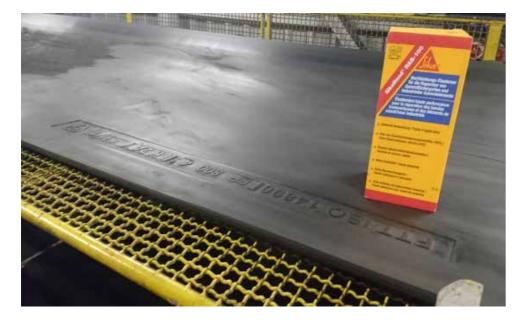
Belt before repair. Visible belt punch on the work side
