CORROSION PROTECTION OF THE EASTERN BRIDGE IN TORUŃ

SIKA TECHNOLOGY: SIKACOR® EG

THE GEN. ELIZABETH ZAWACKA ROAD BRIDGE IN TORUN

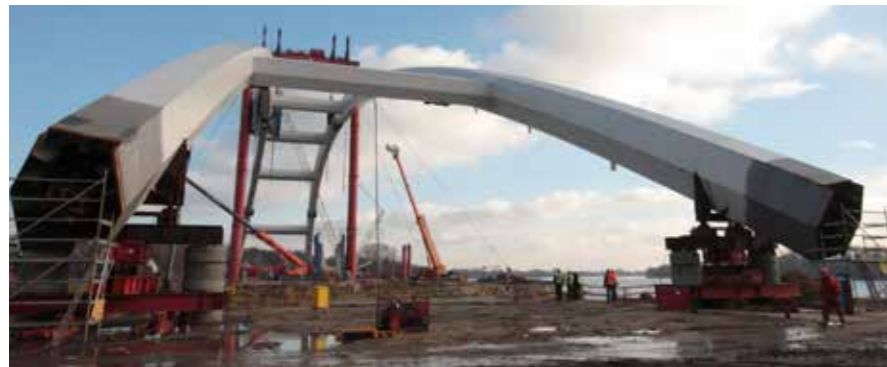
- Technical parameters of the bridge:
- steel construction, two-span, with one central support on the island in the river,
 - length of the bridge: 540 m,
 - two structure spans, each 270 m long, 50 m high and 2.7 thousand tons weight,
 - two-lane bridge roadway, walkway and cycle track with a total width of 24 meters,
 - total length of the bridge road with access roads is 4100 m.

BRIDGE IN TORUŃ HAS THE LONGEST SPANS OF ARCH BRIDGE IN POLAND. EACH OF THEM IS 270 M LONG.

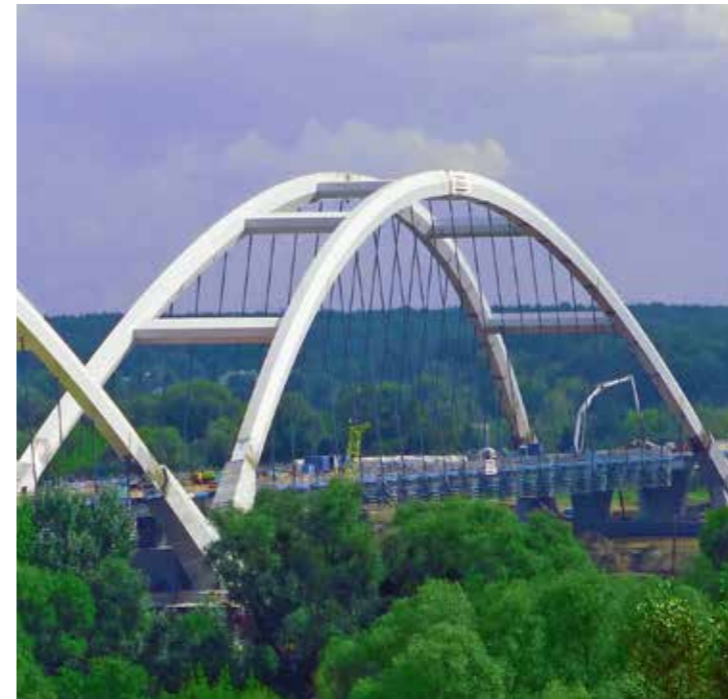
The steel construction of the bridge required corrosion protection, guaranteeing effective protection for many years. Steel surfaces, which should have been applied with anti-corrosion system, included the arch with the inner surface of approximately 35,000 m² and external of approximately 12,000 m². In addition, the other parts of the bridge, approximately 60,000 m² in total, required the corrosion protection too. The corrosion protection system in accordance with the project requirements were to have 25-year service life.

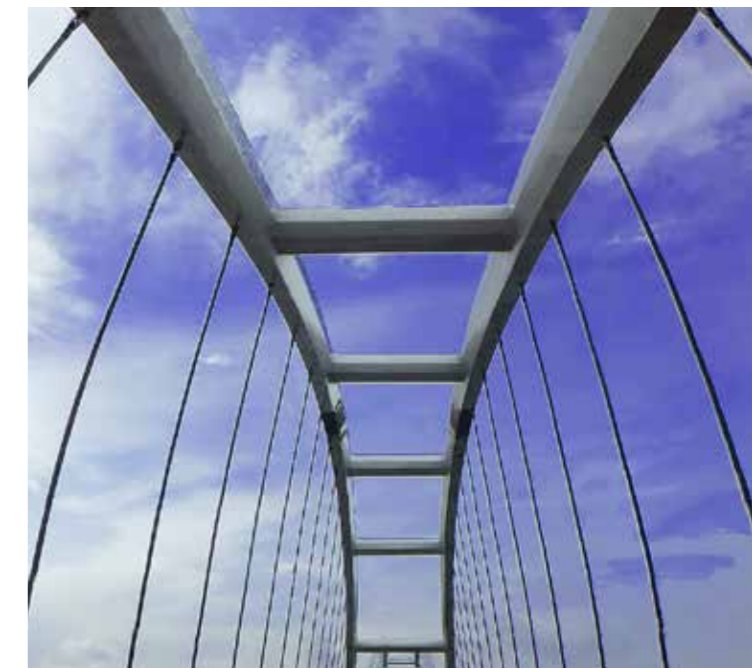
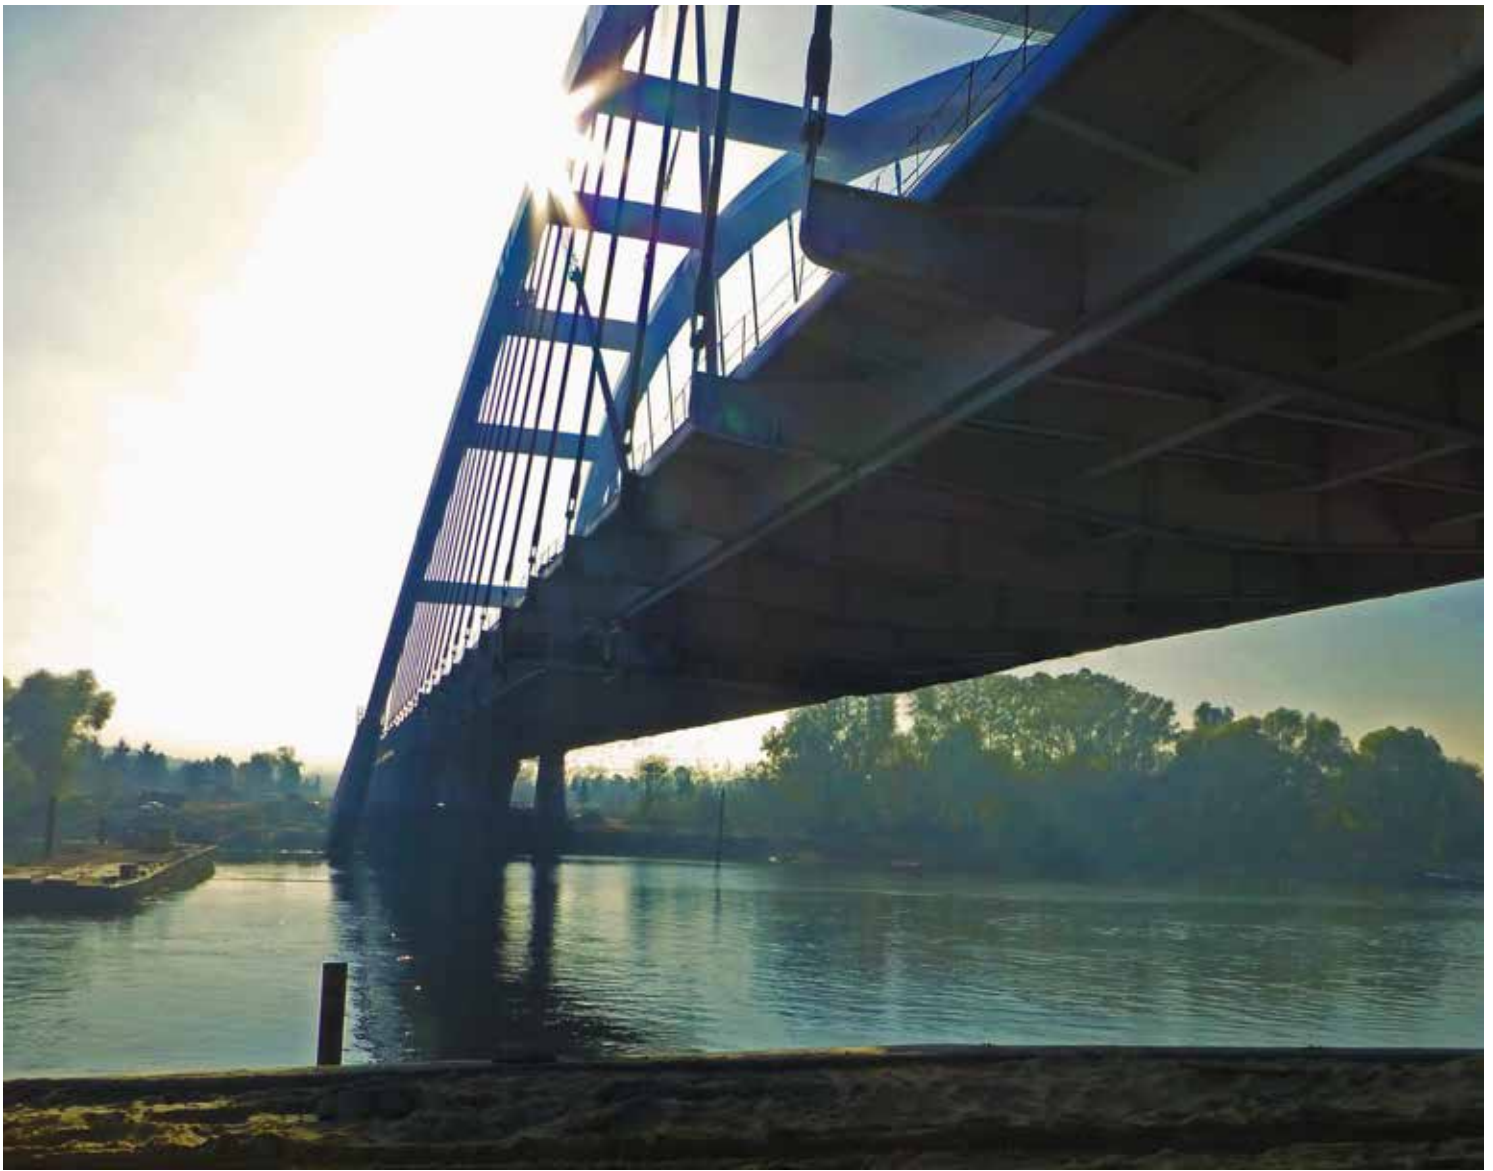
For corrosion protection of the external steel surface used the following products: SikaCor® EG Sealer - an epoxy sealer coating in white colour, SikaCor® EG 1 - an epoxy coating containing micaceous iron oxide in DB 702 and DB 703 colours and SikaCor® EG 5 - a polyurethane top coating in grey and blue colours.

For corrosion protection of the inner surface used the following products: SikaCor® Zinc R - a zinc-rich, epoxy primer in zingrau colour and SikaCor® EG 1 - an epoxy coating containing micaceous iron oxide in DB 702 and DB 703 colours.

Additionally, SikaCor® Elastomastic TF was used to perform waterproofing and surface pavements on a total area of approximately 14,000 m², including about 3,000 m² of steel.
