SIKA AT WORK

SIKA CAR PARK SYSTEMS FOR
MANUFACTURA, ŁÓDŹ, POLAND

FLOORING: Sikafloor®

HIGH RISK CAR PARK DECK SUBJECT TO SIGNIFICANT LEVELS OF MOVEMENTS AND LOW TEMPERATURES

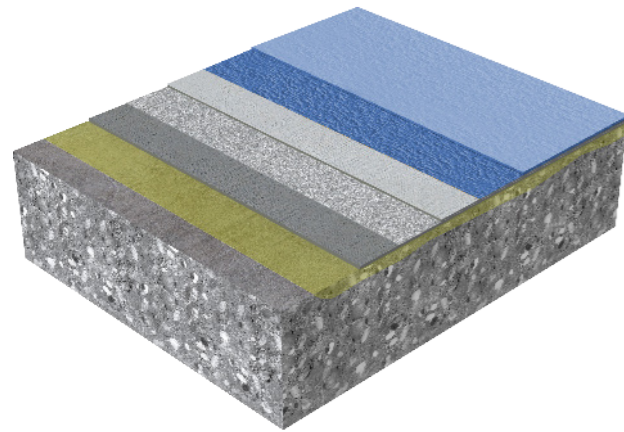
1. Sikafloor® pronto-RB58 SYSTEM FOR TOP DECK

According to the above requirements, the specified system by Sika Poland for this project was the Sikafloor® pronto-RB58 system for the top deck 6,000 m² and Sikafloor® Multidur-ES14 system for the intermediate floor 6,000 m².

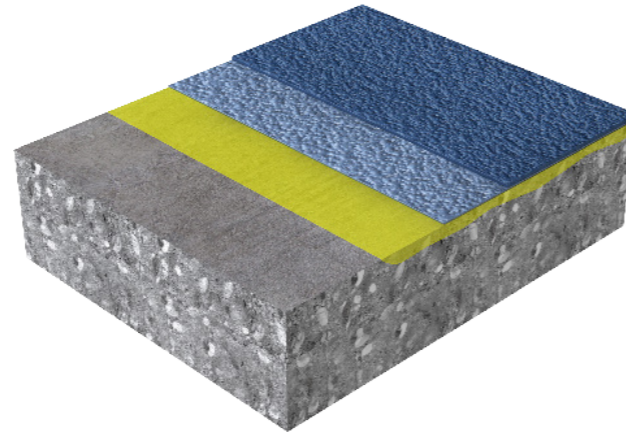
2. Sikafloor® Multidur-ES14 SYSTEM FOR INTERMEDIATE DECK
